# Manhole Inspection Summary

Manhole # S25QQ1022MH

**Location** Address: **6 CLUB RD**

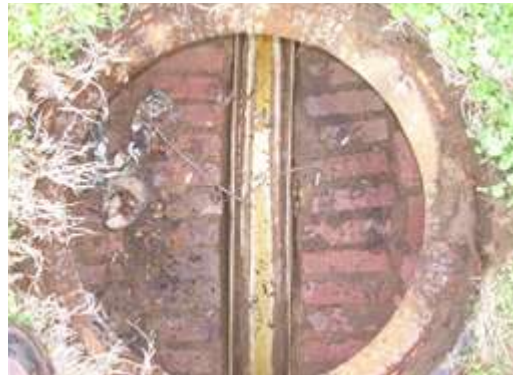
Top View

**Bench** ☒ Exists Material: **Brick** ☐ Parged ☒ **Debris** (not Condition related)

Bench debris.

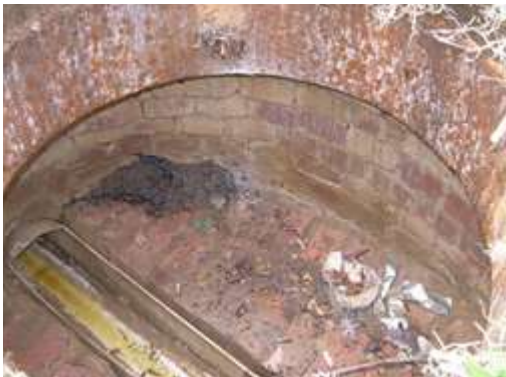
Defect

Condition: ☐ Sound ☐ Cracked ☐ Root Intrusion ☐ Loose Brick ☒ **Deteriorated**

Infiltration: ☐ None ☒ **Joint** ☐ Cracks ☒ **Mortar** ☐ Roots ☐ Wall

Infiltration: ☐ None ☐ Joint ☐ Cracks ☒ **Mortar** ☐ Roots ☒ **Wall**

Corbel and Barrel deterioration and infiltration.

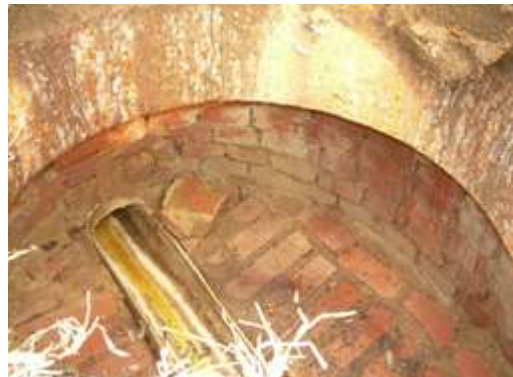
Defect

Corbel and Barrel deterioration and infiltration - other side.

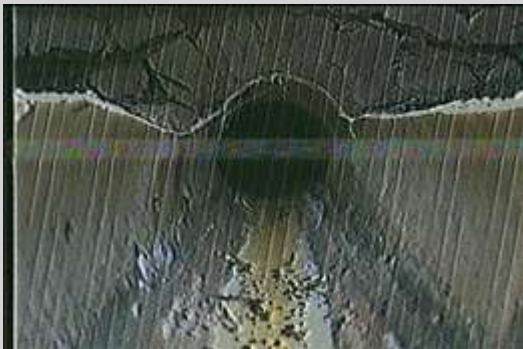
### 6 in. Circular Gravity Sewer Pipe In @ 6 O'Clock

Barrel deterioration and infiltration.
